## LOWER KOSHKONONG CREEK WATERSHED (LR11)

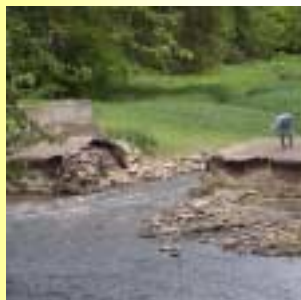
*WDNR staff studies the breached Rockdale dam before completely removing the remaining structures.*

**Koshkonong Creek (Lower)** This reach of Koshkonong Creek still flows in its natural channel for most of its distance. Lower Koshkonong Creek is a low-gradient, meandering stream, which has formed a small delta at its mouth on Lake Koshkonong. The only impoundment on the creek, the Rockdale dam, was breached in September 2000 and removed in June 2001. Stream bank restoration and revegetation to reduce sedimentation downstream is in progress. The removal of the Rockdale dam will improve fish migration and habitat quality of the stream. A partnership with the University of Wisconsin-Madison will provide a detailed analysis on sedimentation movement after dam removal. The stream is classified as a warm water sport fishery, but its uses and potential are impaired by agricultural runoff. Highly intensive agricultural operations, including one muck farm, in the drainage area affect water quality. The Upper Koshkonong Watershed contributes a significant portion of nutrient and sediment loads.

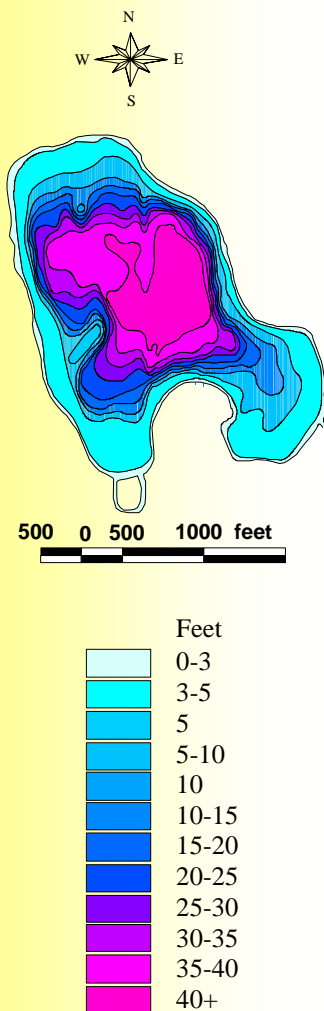
*Lake Ripley: depth profile*

In 1993 the lake experienced its first reported blue-green algae bloom. High precipitation levels that year and ensuing years have contributed to the influx of pollutants, reflecting the primary source of nutrients--watershed contributions. Lake Ripley is dimictic, meaning it stratifies twice yearly, becoming anoxic in its hypolimnion during winter and summer. This condition likely contributes phosphorus from in-lake sediment during spring and fall mixing; WDNR researchers are involved in estimating in-lake sediment contributions to overall phosphorus loading rates. The lake's priority watershed plan should guide management efforts into the future.
